A-69

3.2.3 Probable Diesel Source

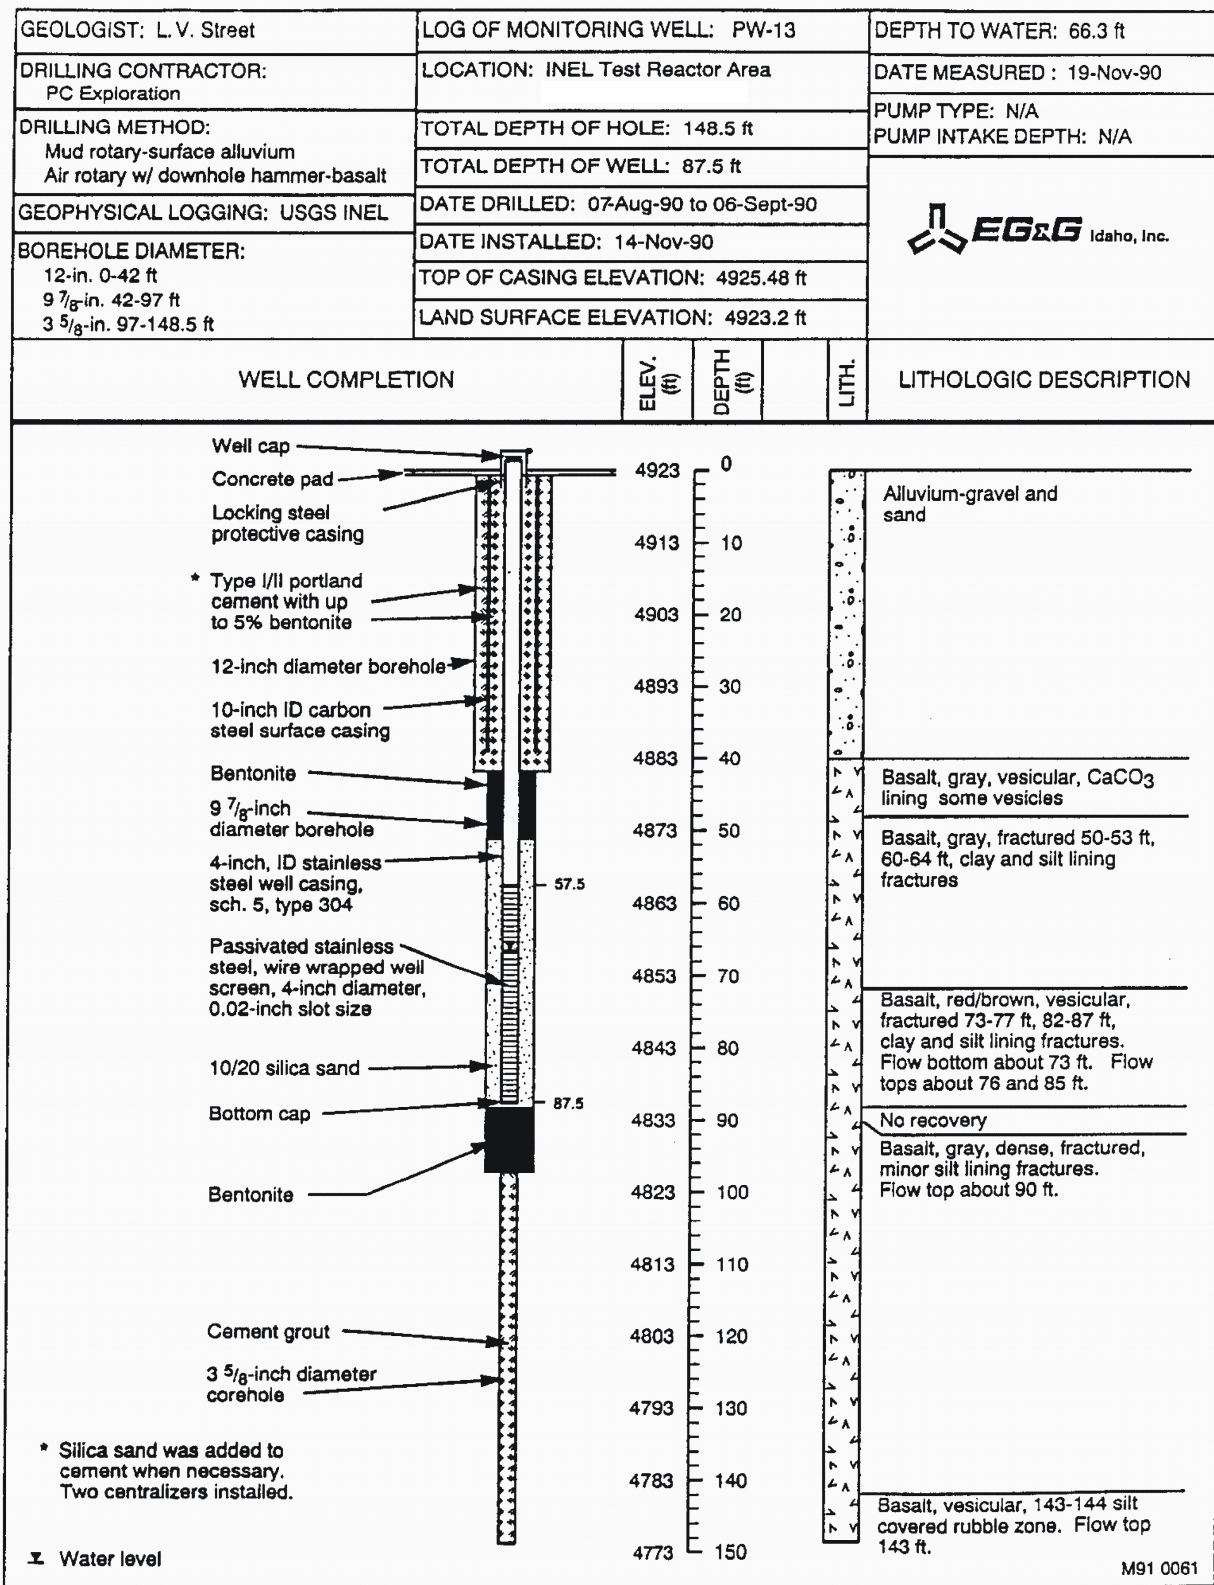
Figure 11. Well completion diagram and lithology of the Test Reactor Area Perched-Water Well PW-13.

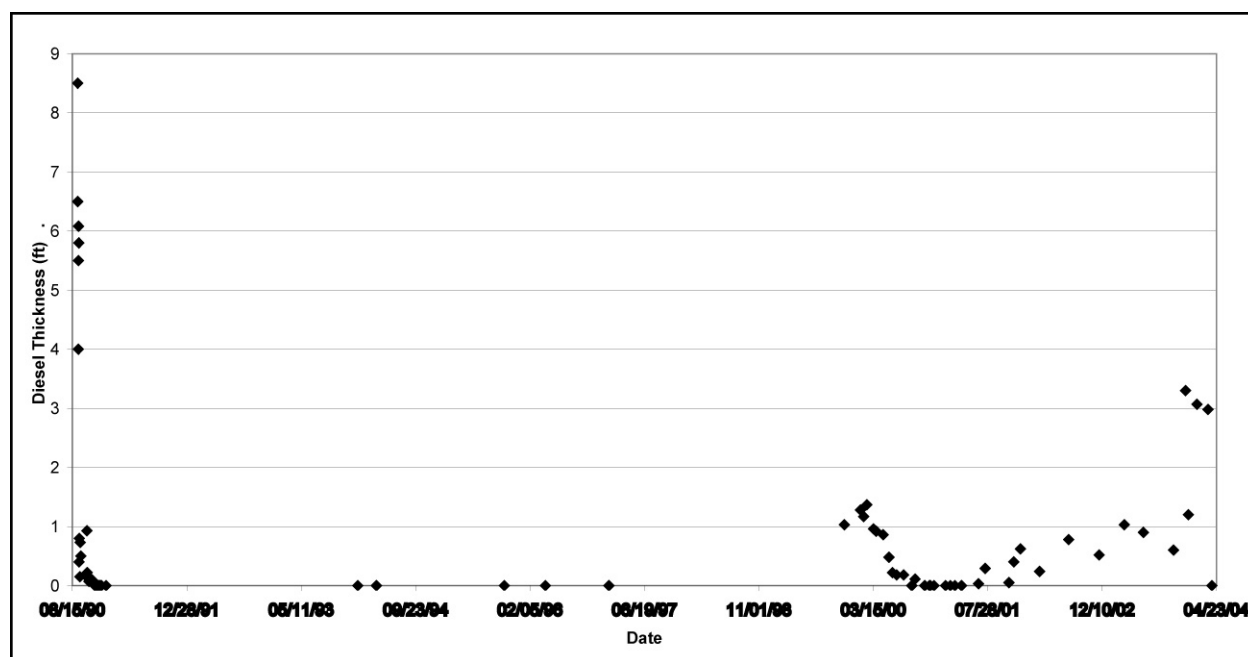
Water level and diesel thickness in Well PW-13 were measured six times between December 1990 and April 1997, with no discovery of free product. The next measurement in November 1999 reported a 1.03-ft layer of floating diesel. Thickness of the floating diesel increased to 1.37 ft in February 2000, and then it began decreasing. No free product was measured in August 2000. A diesel thickness of 0.11 ft was measured in September 2000, but none was found in November 2000. Measurements made since June 2001 have indicated a continued presence of diesel until April 2004. Measurements made during this investigation have recorded diesel thicknesses of 3.3 ft and 1.2 ft in December 2003; in January 2004, 3.07 ft of diesel was measured. A measurement of the diesel thickness in April 2004 indicated that no measurable thickness was present in the well. However, Well PW-13 was sampled in March 2004 and the diesel may not have had sufficient time to accumulate in the well. A thickness of 2.98 ft was measured in the well in March prior to sampling; no further measurements were made until April 2004. Figure 12 shows the history of diesel thicknesses in PW-13.
